# Dye-tracing on Khumbu Glacier

Field Campaign to Khumbu Glacier, April-May 2018

Final Report to the Mount Everest Foundation

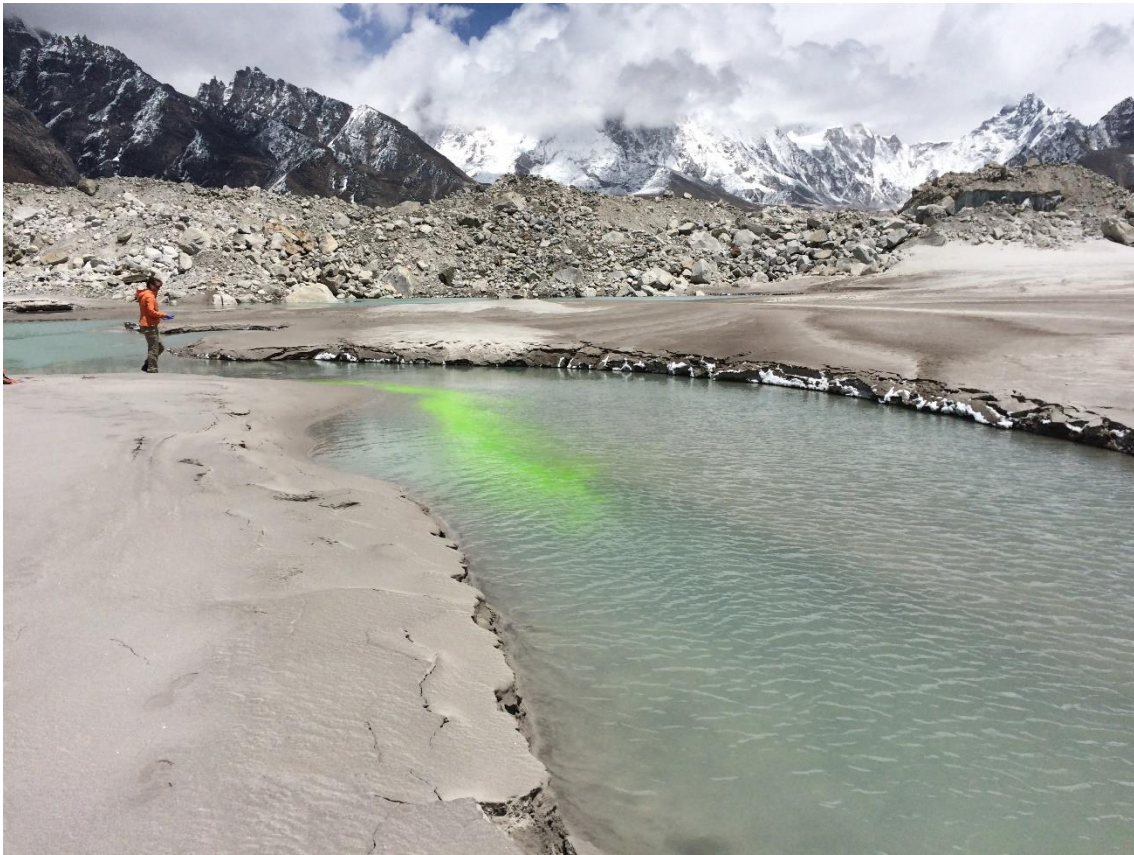
*Figure 2: Example dye injection during a dye-test from DIP1, at the terminus of Khumbu Glacier*

information about how meltwater is transported through such ponds. An example successful dye-return (the same as that carried out in Figure 2) is shown in Figure 3.

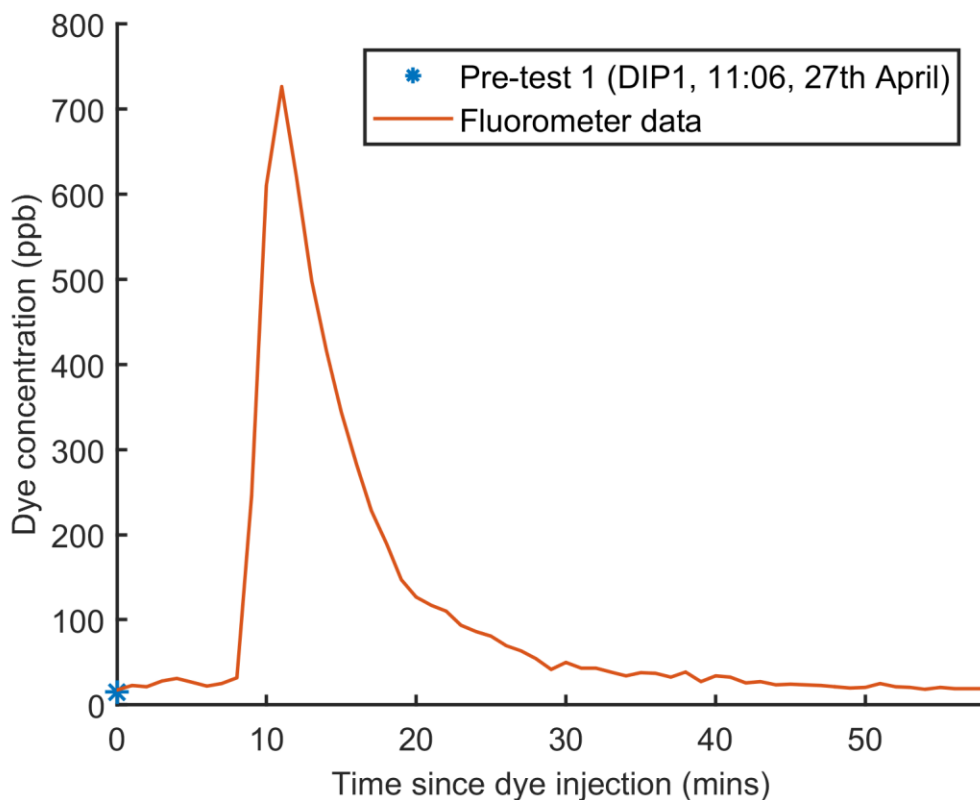
Figure 3: Example dye-return from a fluorometer during the very first dye-test into DIP1 (Fig. 1). The blue star indicates the dye injection. An image of this injection can be seen in Fig. 2.

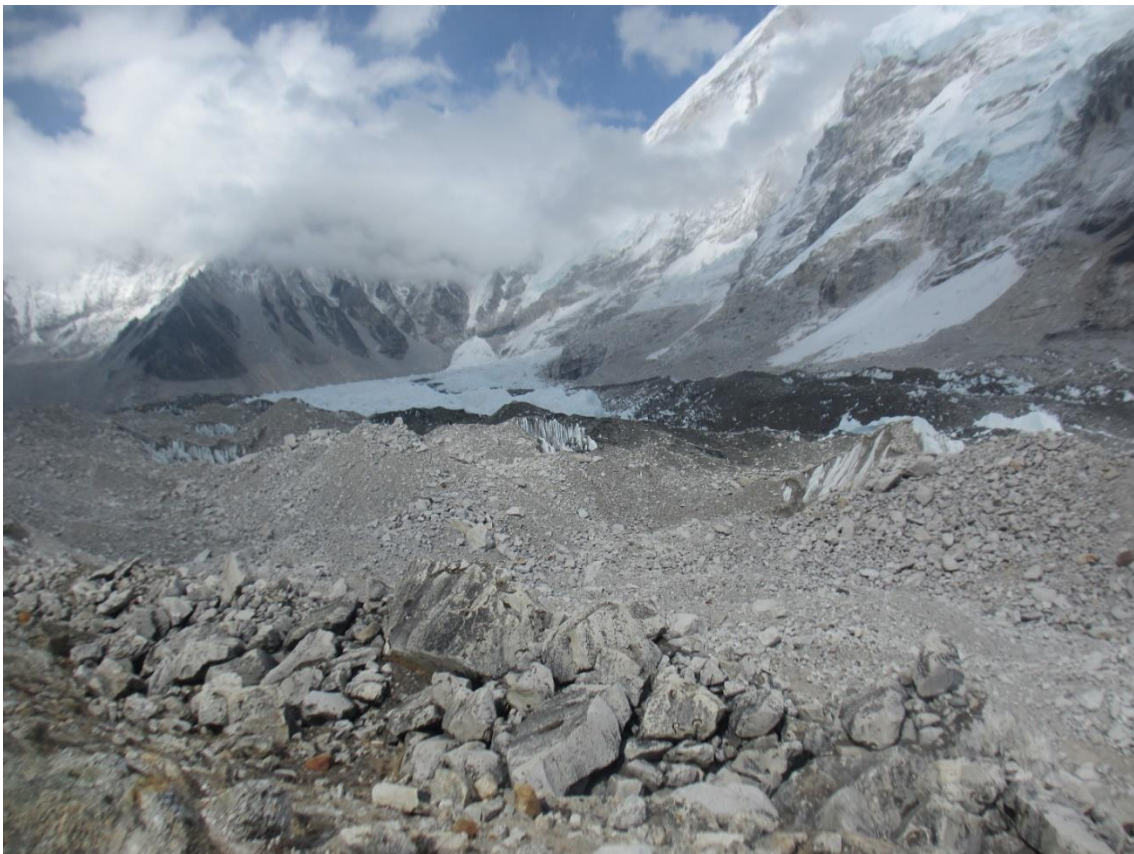
*Figure 4: An image of Khumbu Glacier, taken from between Gorak Shep and Everest Base Camp. The image looks upglacier (upvalley), towards Everest Base Camp (far left of image) and the Khumbu Ice Fall (far centre of image).*

Images of Khumbu Glacier taken from between Gorak Shep and Everest Base Camp are provided below, looking both upvalley towards Everest Base Camp and downvalley towards Lobuche (Figures 4 & 5). I have many photos of localised areas of Khumbu Glacier, particularly near dye injection and detection sites, which I am very happy to provide if specific images/regions are requested.

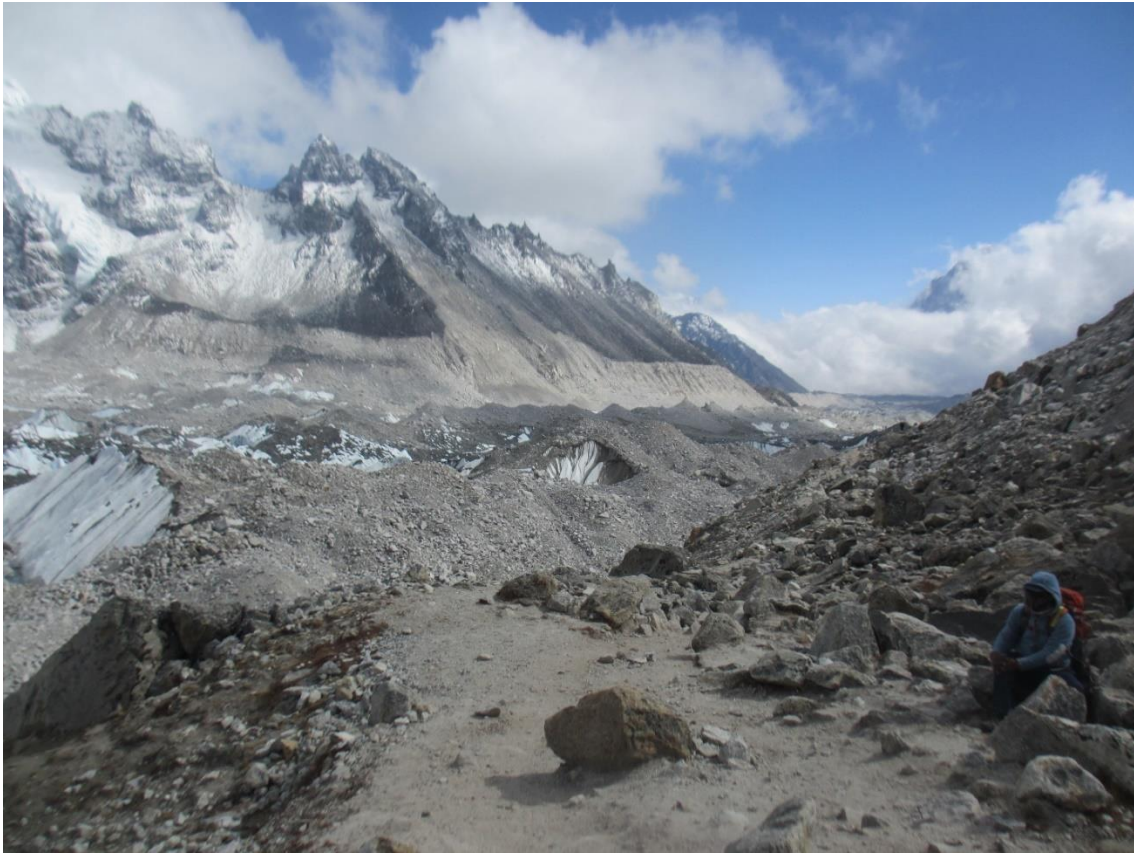
*Figure 5: An image of Khumbu Glacier, taken from between Gorak Shep and Everest Base Camp. The image looks downglacier (downvalley), towards Lobuche village and the glacier terminus.*
